INVESTIGATION NO. 2905

THE MICHIGAN CENTRAL RAILROAD COMPANY

REPORT IN RE ACCIDENT

JUNE 30, 1945

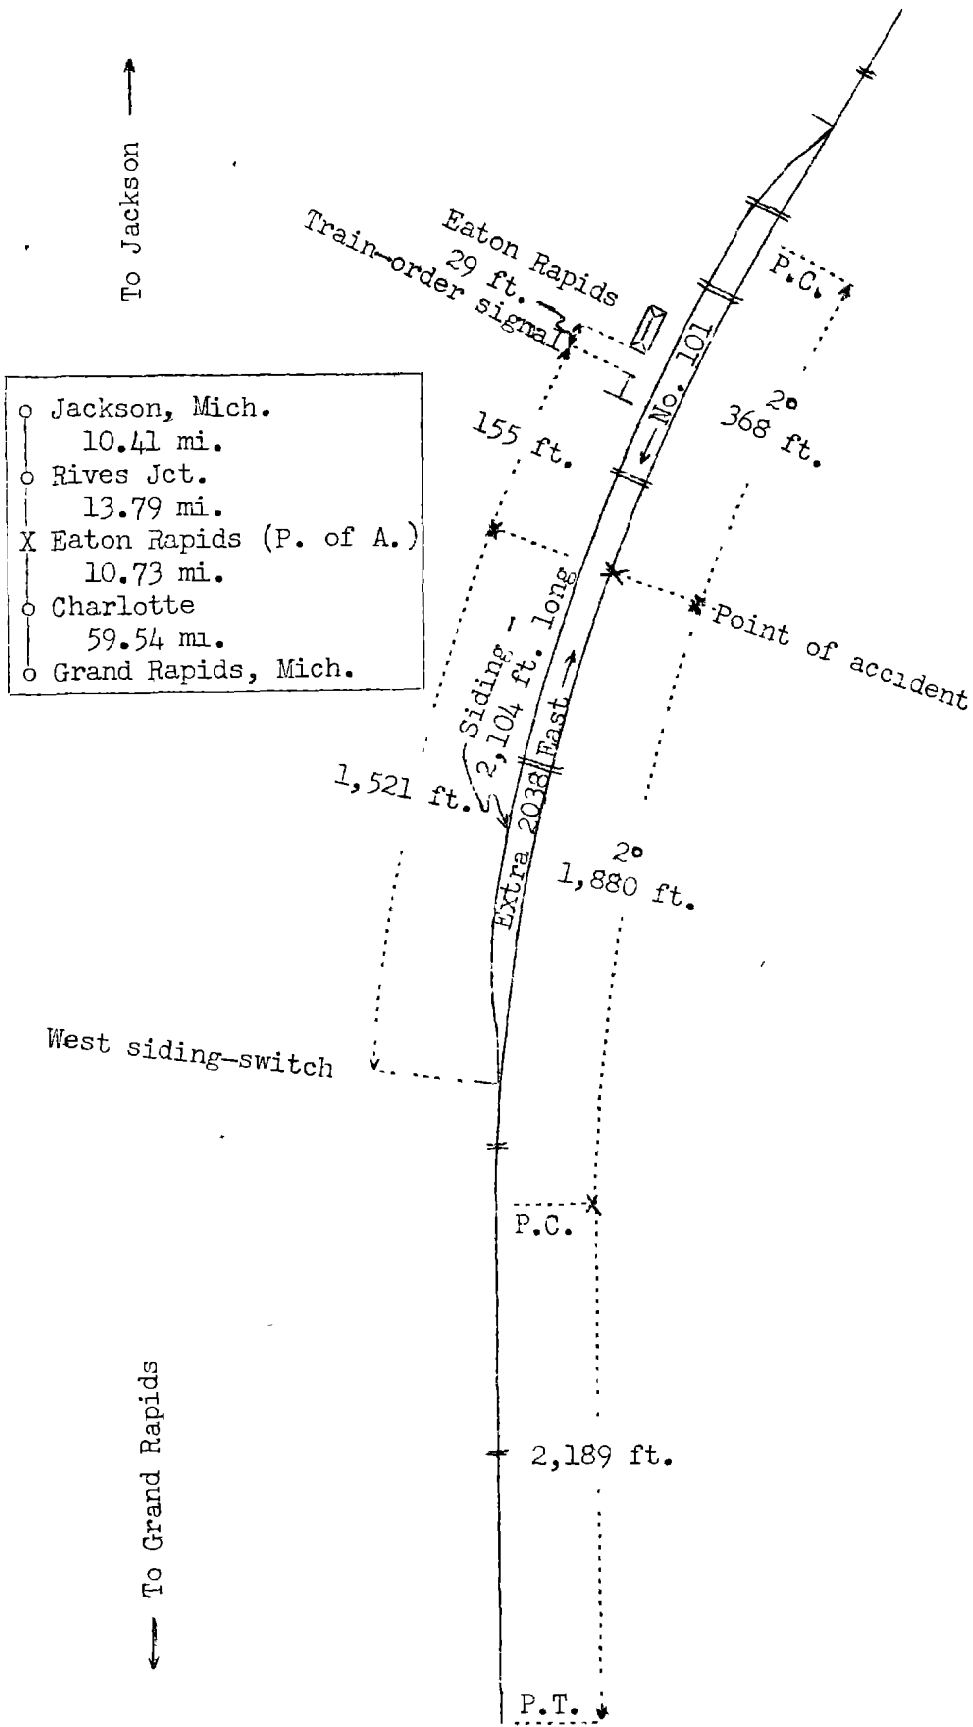
Inv. No. 2905
 Michigan Central Railroad
 Eaton Rapids, Mich.
 June 30, 1945

- o Jackson, Mich. 10.41 mi.
- o Rives Jct. 13.79 mi.
- X Eaton Rapids (P. of A.) 10.73 mi.
- o Charlotte 59.54 mi.
- o Grand Rapids, Mich.
