RAILROAD ACCIDENT INVESTIGATION

Report No 3775

THE NEW YORK CENTRAL RAILROAD COMPANY

Accident at White Pigeon, Mich , on November 16, 1957, caused by excessive speed entering a turnout

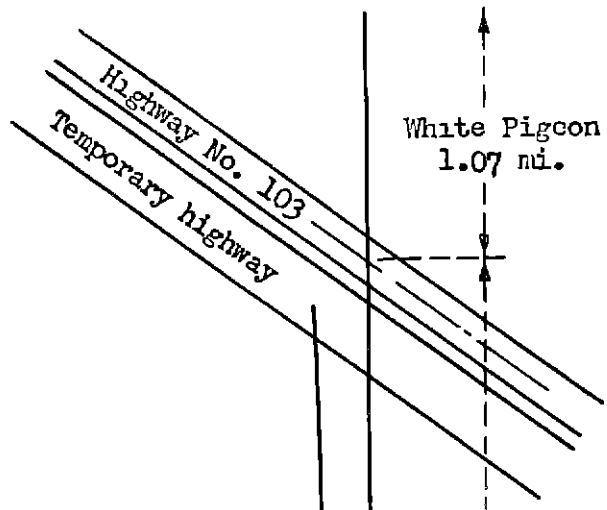
The New York Central Railroad
White Pigeon, Mich.
November 16, 1957

Point of accident

No. 10 turnout

Examination of the turnout disclosed that the switch rails had been forced eastward a distance of about 3 inches. The first mark of derailment was a flange mark on the base of the south side of the south closure rail at a point 29 feet 7 inches east of the switch point. Opposite this point and throughout a distance of about 5 feet the north closure rail was canted outward. The canting extended to the east joint of the rail at which point the joint-bar bolts were broken and the north closure rail east of that point was torn out. The frog was badly damaged. The track was destroyed throughout a distance of approximately 370 feet immediately east of the frog.

This accident was caused by excessive speed entering a turnout.

It is recommended that whenever speed restrictions are imposed, because of line changes or for operational or other reasons, which materially modify the previous maximum permissible speed in a specific area or location, the carrier provide, as additional protection, adequate warning signs in approach to the point where such restriction applies.
