NATIONAL TRANSPORTATION SAFETY BOARD

RAILROAD ACCIDENT REPORT

DERAILMENT OF
CSX TRANSPORTATION INC. FREIGHT TRAIN
AND HAZARDOUS MATERIALS RELEASE
NEAR FREELAND, MICHIGAN
ON JULY 22, 1989

ADOPTED: JULY 23, 1991

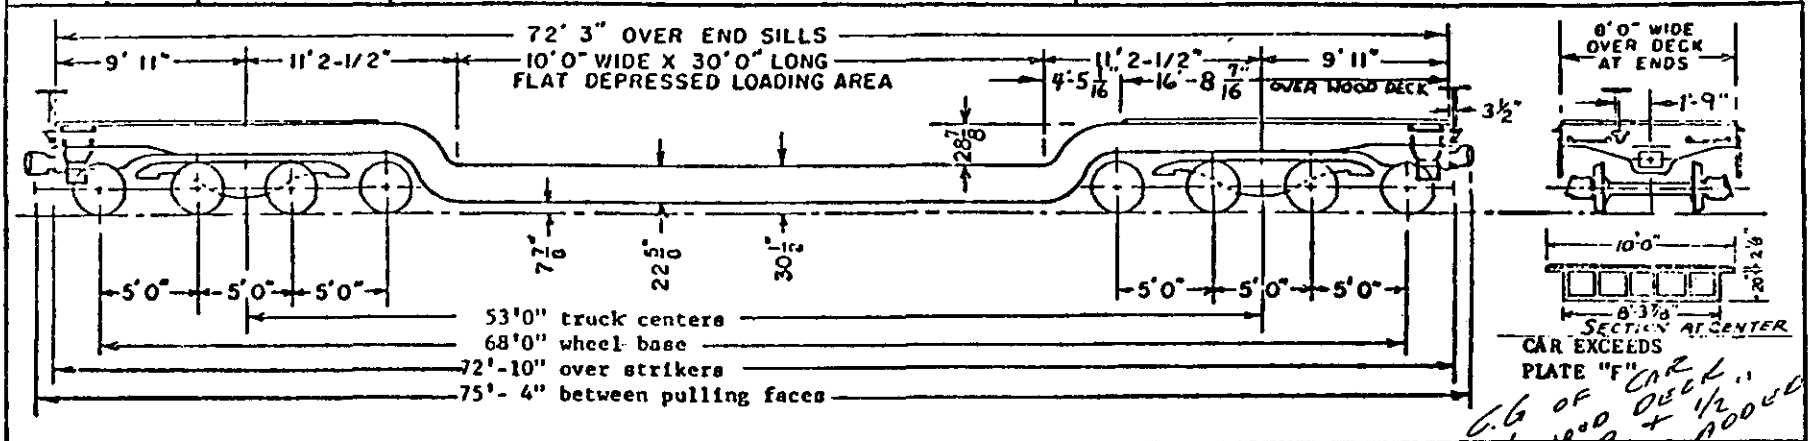
A postaccident inspection of ATSF 90005 revealed that the number 2 axle had been in contact with the B-end⁵ span bolster at least twice, once on the right and once on the left side of the span bolster directly above the number 2 axle. The metal transfers on the left side were unoxidized; the contact on that side centered on the span bolster about 13 inches in from the L2 (second wheel, left side) wheel flange. An 8-inch cone-shaped wear pattern was evident on the left side contact point of the span bolster, metal had extruded onto the leading⁶ edge. The right side of the span bolster evinced a similar 6-inch conical pattern, and metal transfers were present on the number 2 axle beneath the contact point. The span bolster abrasion surface on the right side and the metal transfers on the axle beneath that abrasion were oxidized.

The car had hanger-type brake beams. The brake shoes on both B-end trucks had been overriding.⁷ The R1, L2, R3, and L4 had been overriding the wheel flanges, the L1, R2, L3, and R4 had been overriding the outside edge of the wheel rims. The overriding brake shoes were at diagonally opposite locations on each truck. The shoes contacting the wheel flanges had contoured to the flange profile, and some were worn about 50 percent cross-sectionally through the brake shoe.

Part of the R2 wheel flange had worn away continuously around the circumference at the point of wheel-rail interface. The wear angle formed at the juncture of the tread and flange was sharply defined, and no metal extruded onto the flange. Wear began near the apex of the wheel flange, extended inward toward the hub, and ended about 3/8 inch above the tread surface at the throat of the flange. The wear surface face was smooth, and the fracture surface of the interior wear surface edge was irregular. The interior edge was about 1/16 inch from a perpendicular at the base of the wheel flange.

When ATSF 90005 was rebuilt in February 1989, according to information provided by ATSF, "it was necessary to place three-sixteenths (3/16) inch to one-quarter (1/4) inch shims in the center bowl of the span bolster on the end of the car that had no side bearing clearance." ATSF stated that "this was done after the original record of repairs was completed and, through inadvertence, no supplemental or amended record was made." No shims were found during the investigation and reassembly of the trucks following the accident.

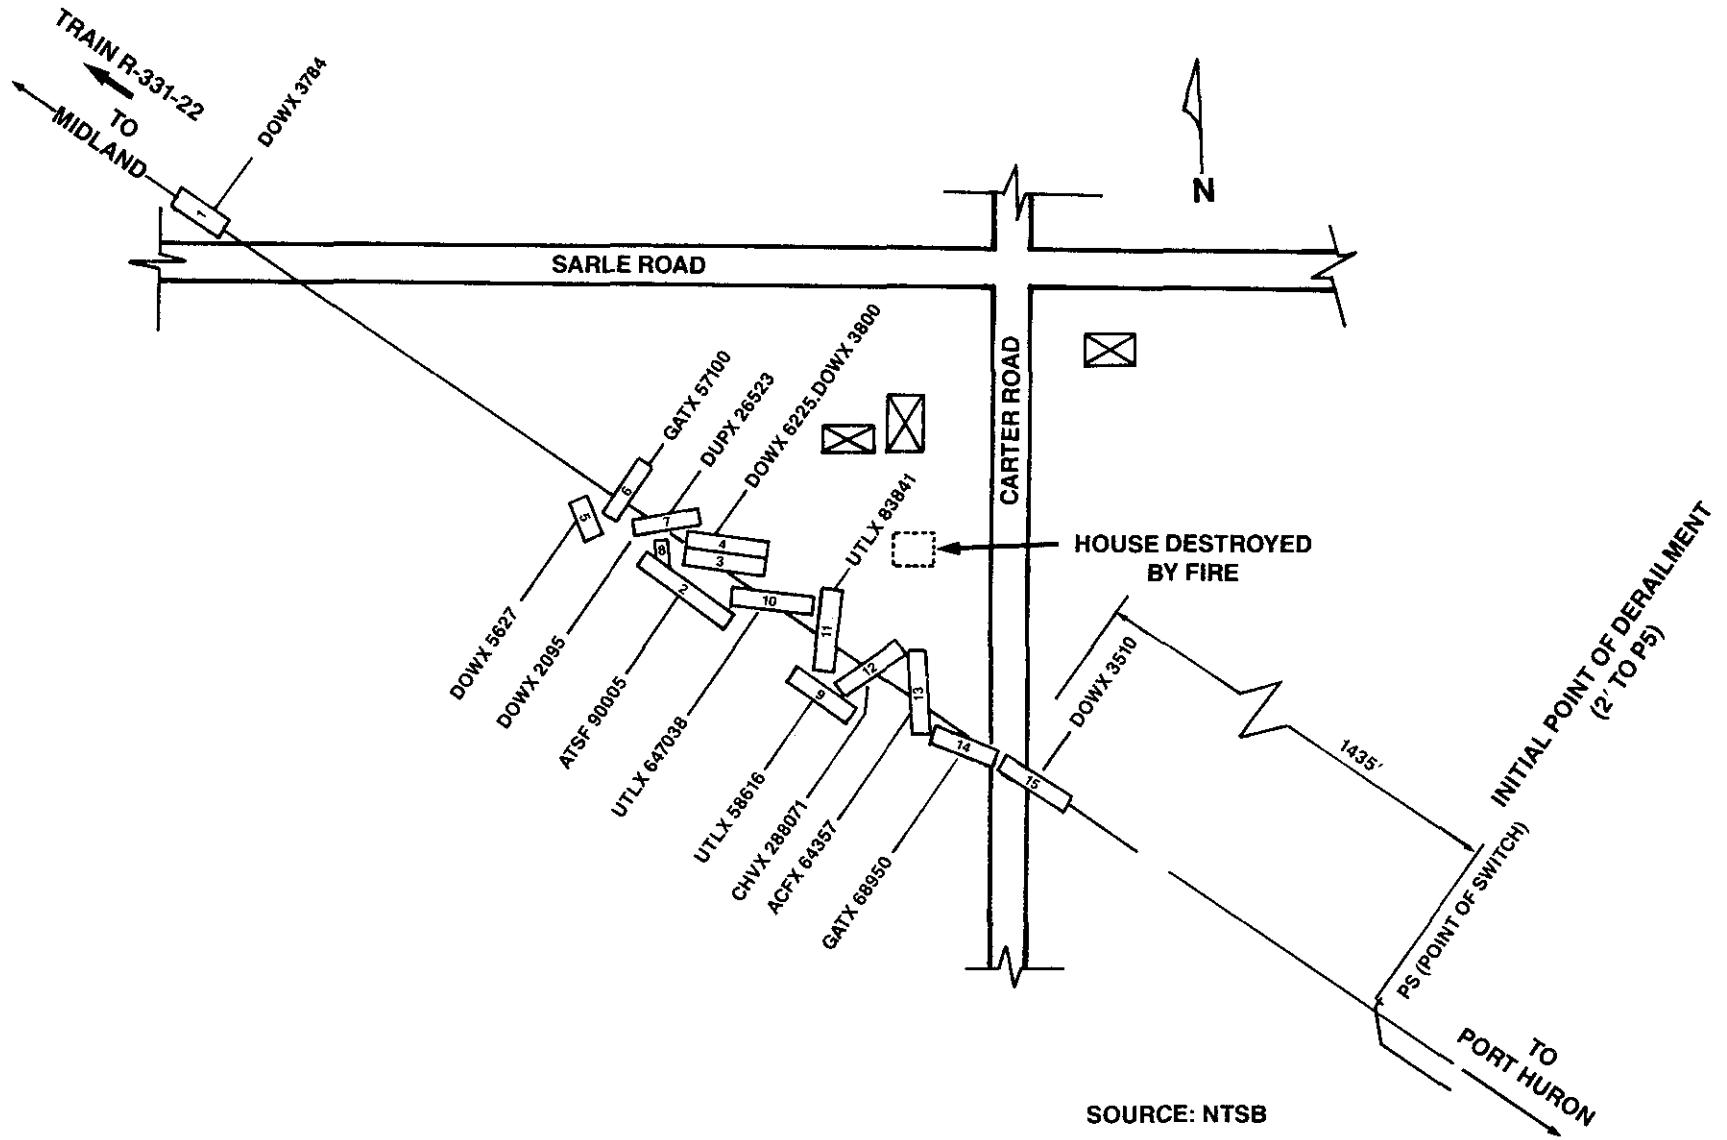
Figure 4 --Identification of derailed cars, freight train R-331-22.

GATX 57100, DOT 111A100W (6th car), was not equipped with a head shield (a supplemental heavy steel plate on the end(s) of a car) or a jacket (a thin outer shell used to contain insulating material wrapped around the tank), the underframe and the left side at the B-end were severely dented and scraped, the outer leg for the bottom outlet was missing (the leg failed at the shear bolts that attached it to the tank), the A-end head was dented above the center line of the car and the B-end was dented below the centerline of the car, the A-end sill was broken, one coupler was disengaged, and one coupler was broken. The trucks were destroyed.

DUPX 26523, DOT 112A200W (7th car), was not equipped with head shields or a jacket, both ends and the tank shell were dented and scraped (the dent in the A-end head was 14 inches deep and 5 feet in diameter), the A-end sill was bent and buckled, the A-end coupler was disengaged, the B-end knuckle was broken, and the B-end body bolster was bent. Both trucks were derailed.

UTLX 647038, DOT 111A100W6 (10th car), was not equipped with head shields and had a jacket and thermal insulation, the right side of the tank had a 3-inch by 6-inch hole near the B-end (about 2 inches from the seam), the A-end stub sill was bent downward and spread open, the jacket had deep dents in both ends, the jacket was torn near the B-end saddle bracket and at the middle of the car, burn damage to the jacket was extensive,

UTLX 83841, DOT 105A300W (11th car), was not equipped with a head shield but did have a jacket. Both stub sills were damaged, the B-end sill was broken off and missing beyond the end of the car, and the A-end sill was bent downward at approximately a 20-degree angle. Almost all of the B-end head above the centerline of the car was punctured, and the head was severely dented below the centerline. Fire damage to the jacket was extensive. Both couplers were broken, and both trucks were destroyed.

CHVX 288071, DOT 111A100W1 (12th car), was not equipped with head shields but did have a jacket and thermal insulation, the B-end tank head had a 10-inch by 14-inch puncture below the centerline of the car and was dented above and below the centerline, the A-end tank head was dented above and below the centerline of the car, the jacket was dented and scraped near the sill on the B-end, and the jacket was extensively burned on the B-end and partially burned on the A-end. Both couplers were disengaged. The trucks were destroyed.

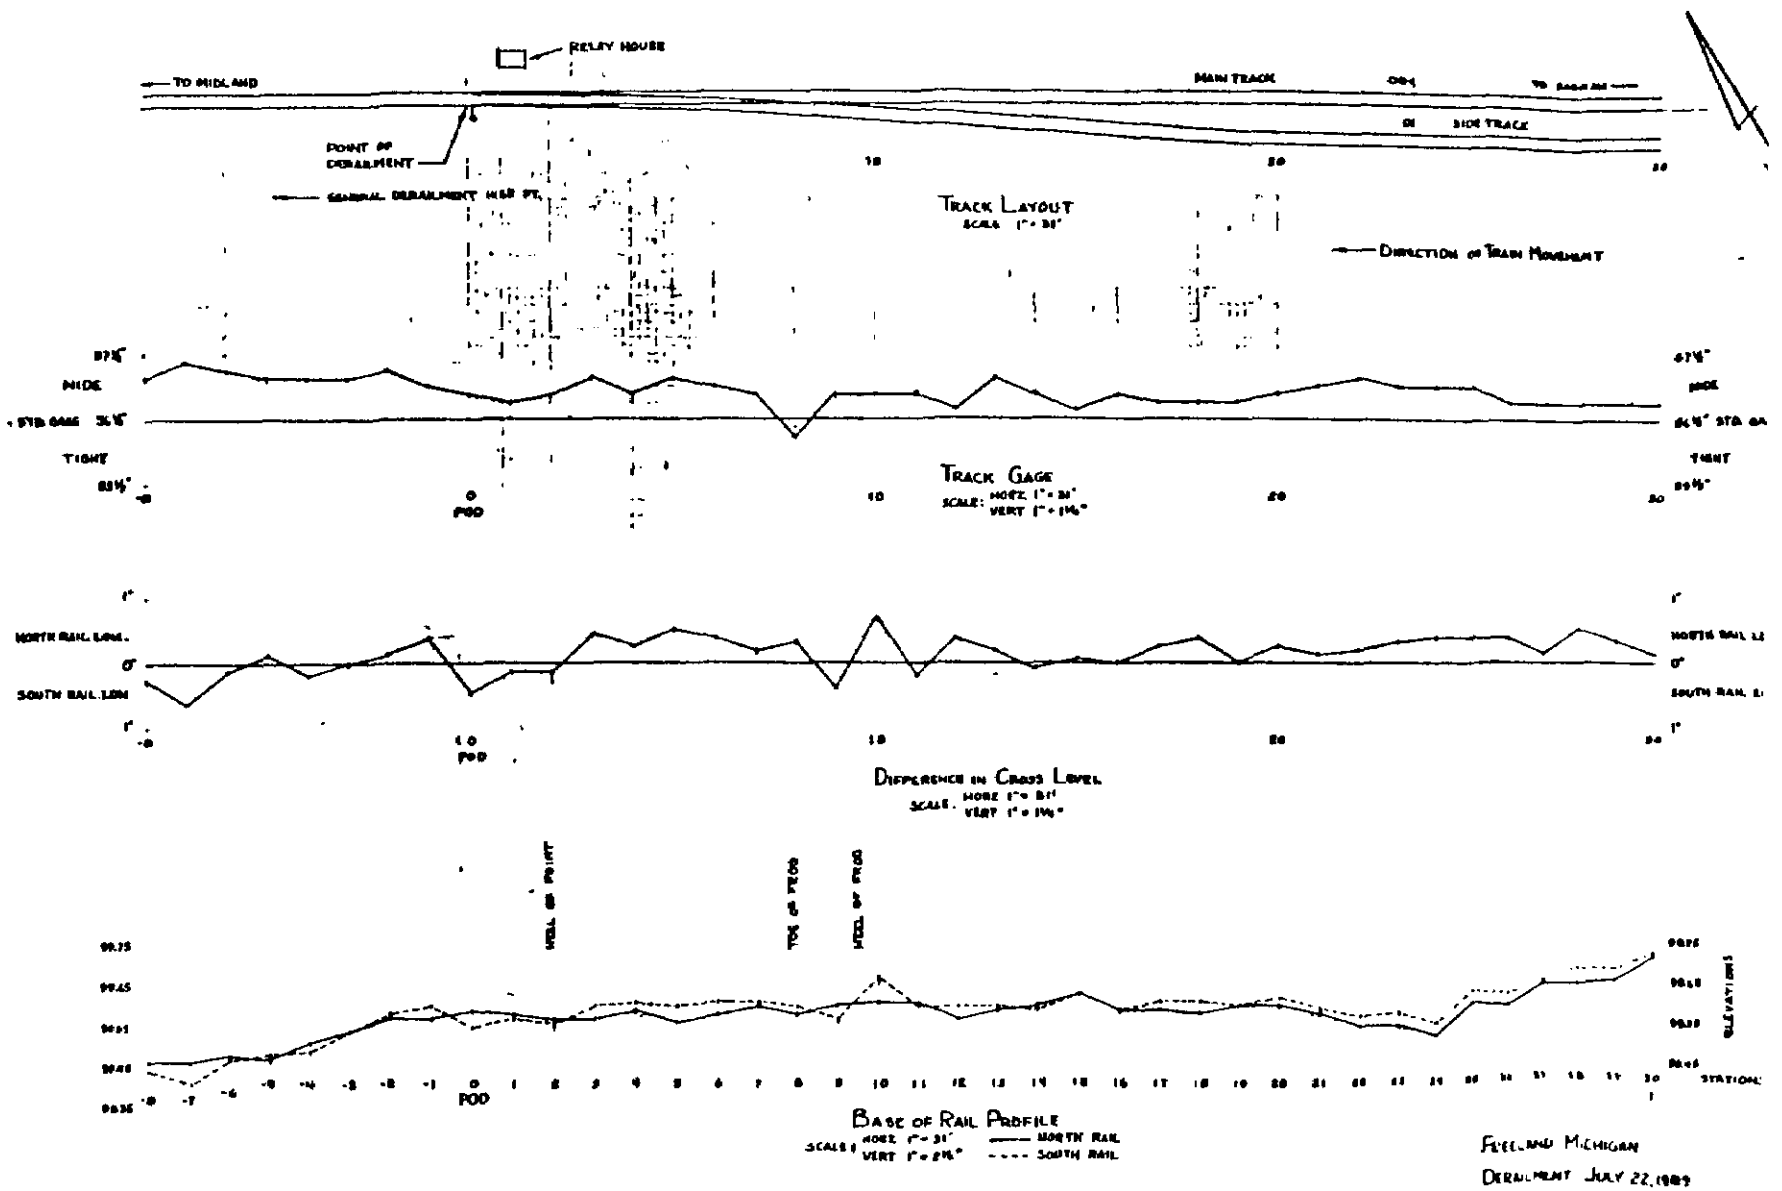
TRACK GEOMETRY MEASUREMENTS

Postaccident Survey --To determine surface conditions after the accident, track geometry was measured at 15 5-foot intervals 465 feet before and 124 feet after the POD, base-of-rail levels and track gauge were measured under load,¹³ and track alignment was measured under static conditions (See appendix D.)

CSX had last operated a track geometry car over this subdivision on June 22, 1989. During that evaluation, a 1 5/8-inch cross level deviation on the north rail was detected at MP 11.9, which was the POD. CSX records indicate that this irregularity in track surface was repaired on June 26; they do not show that any previous accidents had occurred at this location. (Title 49 CFR 213.63 allows a 1 3/4-inch tolerance for class 3 track.)
