INTERSTATE COMMERCE COMMISSION

REPORT OF THE DIRECTOR OF THE BUREAU OF SAFETY IN RE
INVESTIGATION OF AN ACCIDENT WHICH OCCURRED ON
THE MICHIGAN CENTRAL RAILROAD AT WEST DETROIT,
MICH., ON MARCH 19, 1931.

April 22, 1931.

INV. NO. 1698
 MICHIGAN CENTRAL R R
 WEST DETROIT, MICH.
 MARCH 19, 1931.

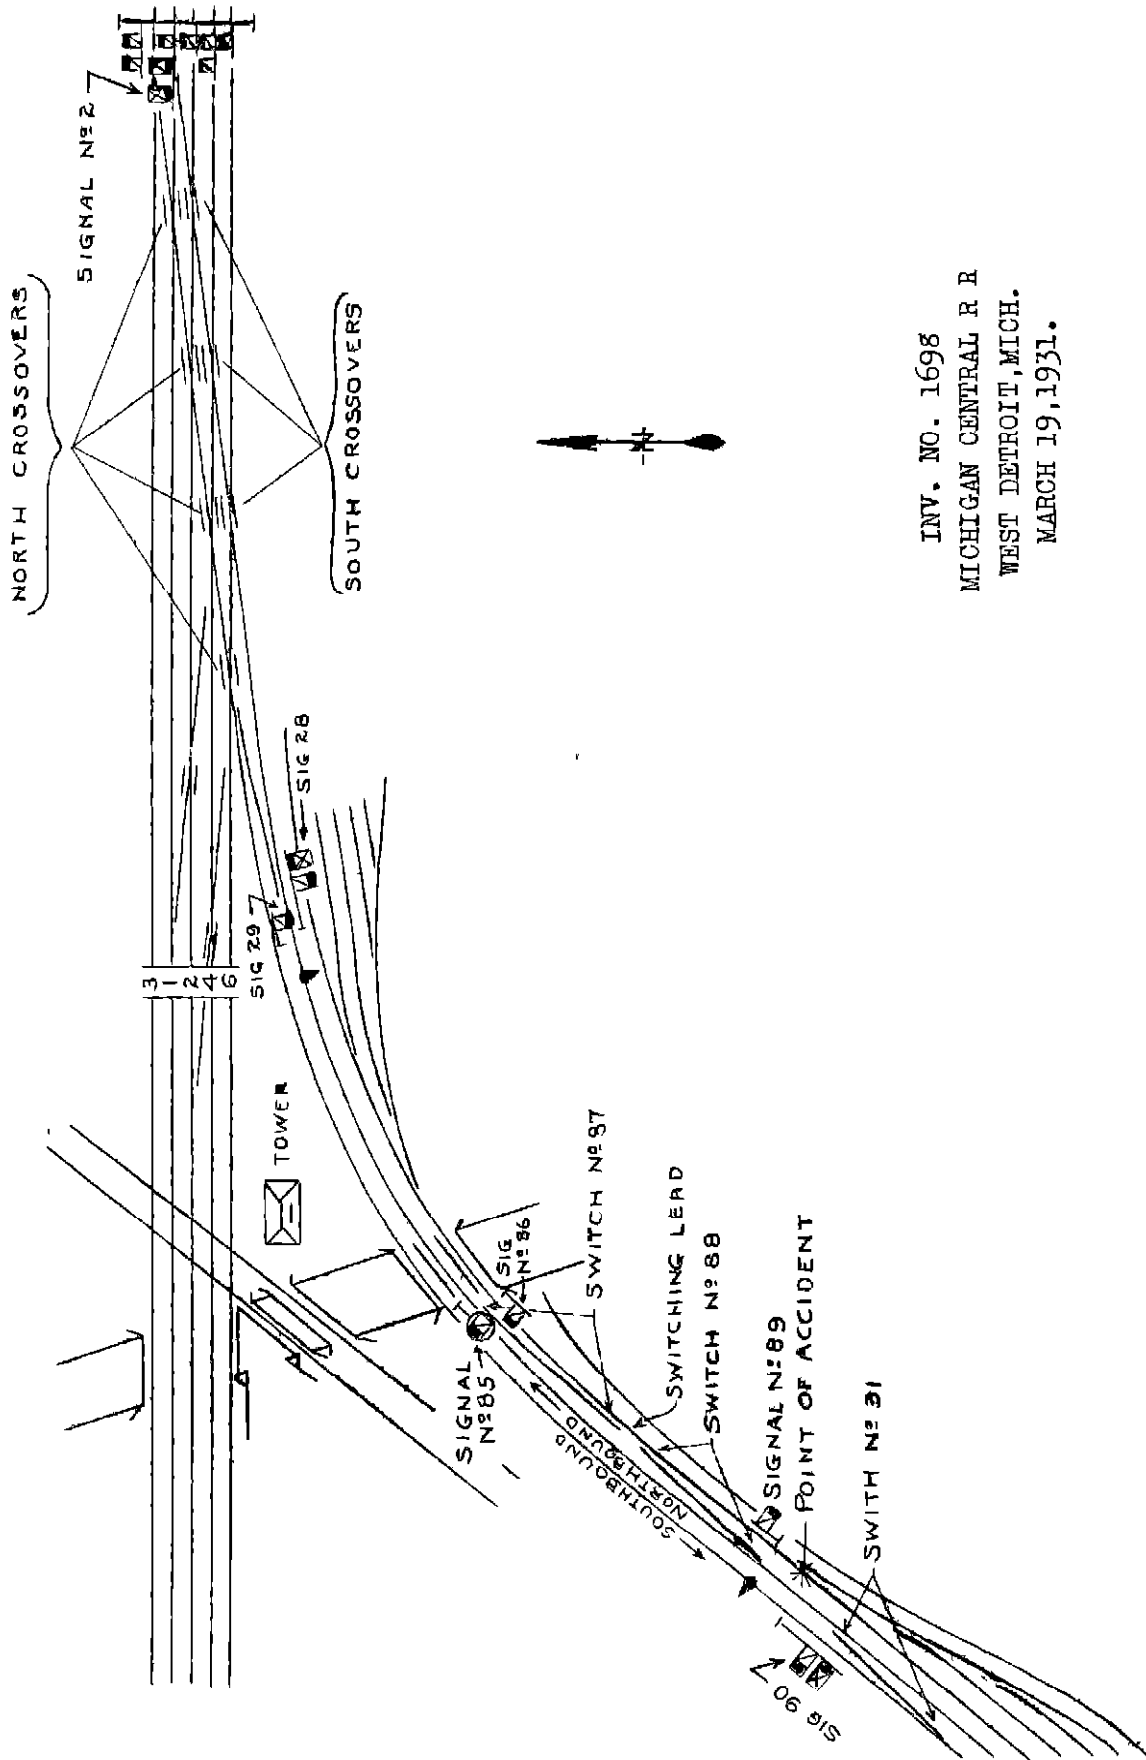
This accident occurred within the territory known as Detroit Yard, at the southern end of interlocking limits. Approaching from the eastern end of the interlocking limits, there is a four-track main line, the tracks being numbered from north to south as follows: 1, westbound passenger, 2, eastbound passenger, 4, westbound freight, and 6, eastbound freight. These tracks were paralleled on the north by a running track, known as track 3. There are two sets of crossovers, herein referred to as the north and south crossovers, respectively, which connect these tracks and extend toward the left or south to the double-track line of the Toledo Division. Train movements on the Toledo Division, beginning in the immediate vicinity of where this accident occurred, are governed by timetable, train orders, an automatic block-signal system, and an automatic train stop device of the intermittent inductive type. The interlocking tower is located in the angle formed by the diverging tracks, at a point approximately 1,200 feet west of the eastern limits of the interlocking plant. At the southern limits of the interlocking plant the tracks of the Toledo Division are paralleled on the east by a series of yard tracks and a switching lead. The accident occurred on this lead track at a point approximately 650 feet south of the tower and about 21 feet outside the western or southern end of interlocking limits, at a switch leading from the lead track to the yard tracks.

The interlocking signals involved are signal 2 and dwarf signal 85. Signal 2, of the three arm, upper quadrant type, the lower arm being a calling-on arm, is located at the eastern limits of the interlocking plant and governs movements approaching on track 1. Dwarf signal 85, of the two-position, color-light type, is located between the two main tracks of the Toledo Division at a point 1,350 feet southwest of signal 2, and is an all-route signal governing reverse movements on the northbound main track. The interlocking plant is equipped with approach route locking and route indicator lighting, which enables an operator to note the route actually lined up as soon as a train enters the route. Special time table instructions provide a maximum speed of 10 miles per hour when a train takes a diverging route from one track to another.
