INTERSTATE COMMERCE COMMISSION

REPORT OF THE DIRECTOR OF THE BUREAU OF SAFETY CONCERNING AN
ACCIDENT ON THE PERE MARQUETTE RAILWAY AT PLYMOUTH,
MICH., ON SEPTEMBER 30, 1932.

December 6, 1932

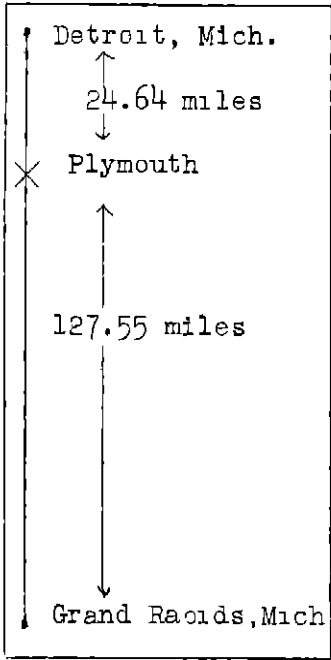
Inv. No 1788
Pere Marquette Railway
Plymouth, Mich.
September 30, 1932.

A house track parallels the eastern portion of the wye, on the south side of it, and immediately south of this house track there is a freight house platform 4 feet 8 inches in height which extends 237 feet west of the east wye switch. The only signal involved is located between the wye track and the house track, 60 feet 8 inches east of the west end of the freight house platform, it is of the searchlight, two-position, dwarf type, displaying yellow for proceed and red for stop, governing movements from the wye to the Detroit-Grand Rapids Division, and is operated in conjunction with the Detroit-Grand Rapids Division automatic signals. Owing to the location of this signal, the view of it from the engine's side of an engine approaching from the south on the wye track is obscured by the platform until the engine reaches a point 592 feet from the signal. There were no cars on the house track which interfered with a view of the signal.
