INVESTIGATION NO. 3006
THE MICHIGAN CENTRAL RAILROAD COMPANY
REPORT IN RE ACCIDENT
AT FORT CUSTER, MICH., ON
JULY 22, 1946

October 10, 1946.

Accident at Fort Custer, near Battle Creek, Mich., on
July 22, 1946; caused by failure properly to control
the speed of both movements on a yard track.

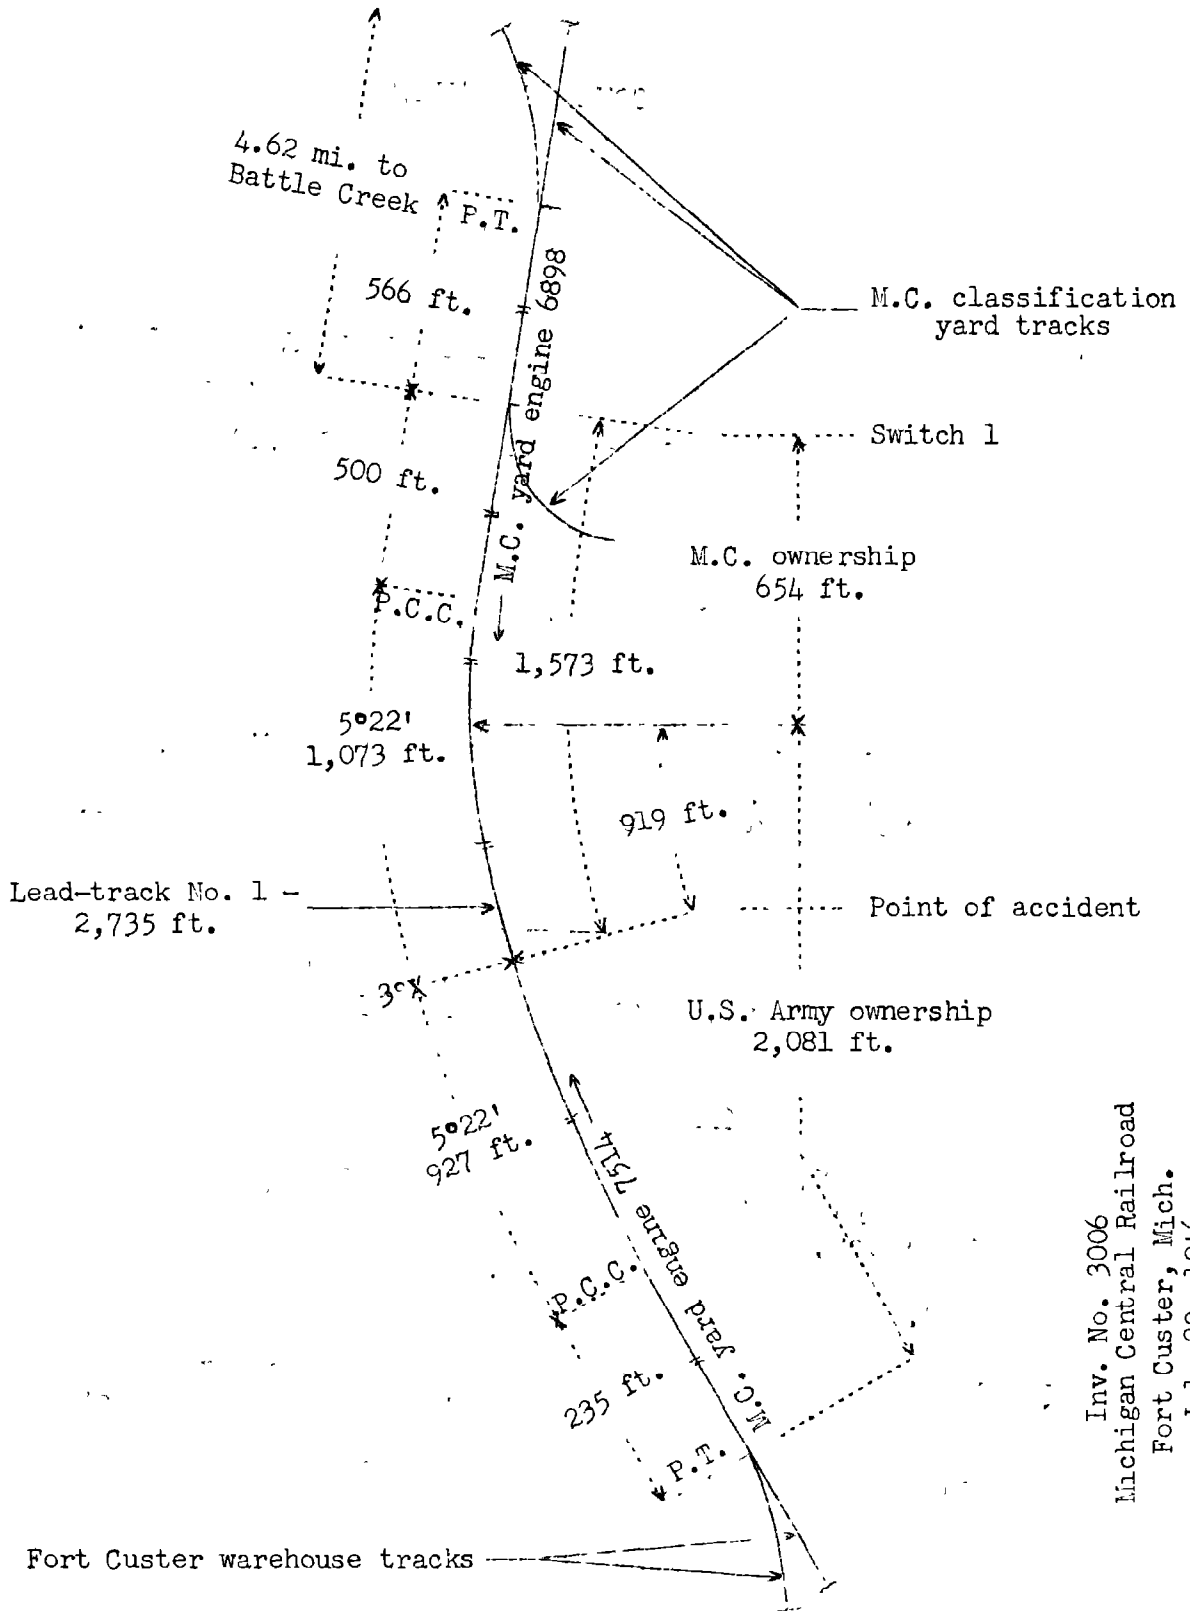
Inv. No. 3006
Michigan Central Railroad
Fort Custer, Mich.
July 22, 1946

This accident occurred on a lead track at Fort Custer, Mich., which connects tracks of a classification yard of the Michigan Central Railroad and warehouse tracks of the United States Army. The lead track is 2,735 feet in length, and is hereinafter referred to as track No. 1. Movement of engines of the Michigan Central Railroad on track No. 1 are governed by operating rules of that railroad. The switch which connects the M.C. classification yard tracks and track No. 1, hereinafter referred to as switch 1, is 4.62 miles west of the M.C. station at Battle Creek, Mich. That part of track No. 1 extending 654 feet west of switch 1 is owned by the M.C., and the westward 2,081 feet of this track is owned by the United States Army. The accident occurred on track No. 1 at a point 1,573 feet west of switch 1 and 919 feet west of the west end of the portion owned by the M.C. From the west on track No. 1, there is a tangent 235 feet in length, which is followed by a compound curve to the right, the maximum curvature of which is 5°22', 927 feet to the point of accident and 1,073 feet eastward. At the point of accident the curvature is 3°. From the east on the M.C. classification yard track to switch 1 thence on track No. 1 there is a tangent 1,066 feet in length, which is followed by the curve on which the accident occurred. At the point of accident the grade is 2.3 percent descending eastward.
