ACCIDENT ON THE
MICHIGAN CENTRAL RAILROAD

WAYNE JCT., MICH.

JULY 5, 1936

INVESTIGATION NO. 2076

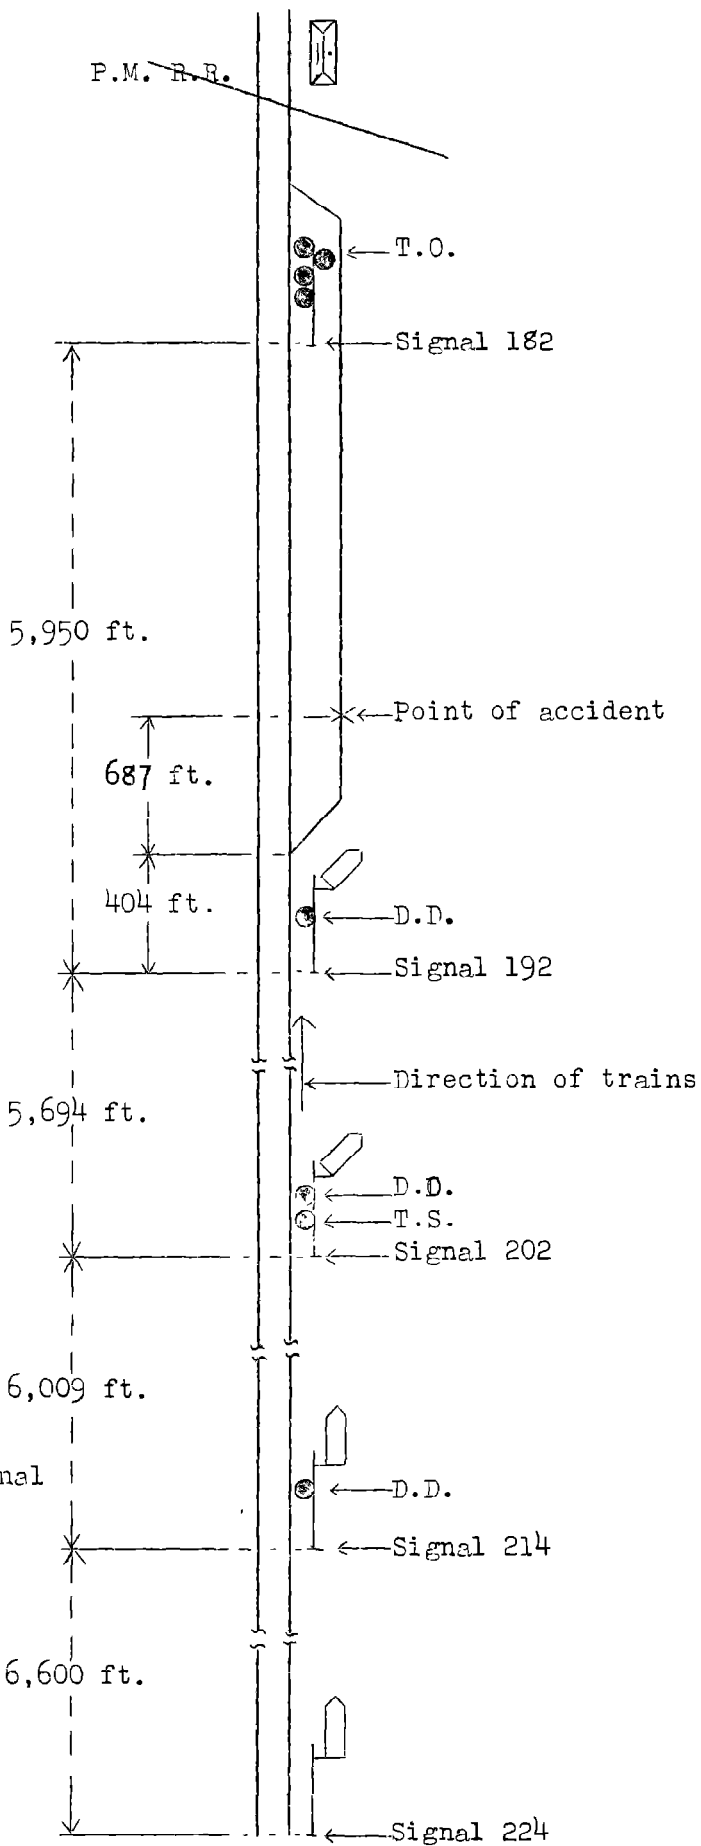
Inv. No. 2076
Michigan Central R.R.
Wayne Jct., Mich.
July 5, 1936

The signals directly involved in this accident are automatic signals 192, 202 and 214, located 404, 6,098, and 12,107 feet, respectively, west of the passing-track switch. These signals are of the upper-quadrant, 3-position, semaphore type, approach lighted; in addition, these three signals are equipped to display three-block indications by the addition of a yellow light to the left of the signal mast, below the semaphore arm. The indications displayed by these signals are as follows: Red, stop then proceed at restricted speed; single yellow, prepare to stop at next signal, train exceeding medium speed (a speed not exceeding 30 miles per hour) must at once reduce to that speed; double yellow, prepare to stop at second signal; green proceed. The additional yellow light to the left of the signal mast is referred to as a "Double-distant signal"; at signal 202, under this double-distant signal, there is a take-siding signal, controlled from the interlocking tower at Wayne Jct., and arranged to display a flashing red light. Turnout switches are equipped with switch circuit controllers adjusted so as to open the contacts when the switch point controlling both sides of the signal control circuits is open 1/4 inch. Automatic train-stop inductors are located approximately 70 feet in the rear of the
