NATIONAL TRANSPORTATION SAFETY BOARD

RAILROAD ACCIDENT REPORT

DERAILMENT OF
CSX TRANSPORTATION INC. FREIGHT TRAIN
AND HAZARDOUS MATERIALS RELEASE
NEAR FREELAND, MICHIGAN
ON JULY 22, 1989

ADOPTED: JULY 23, 1991

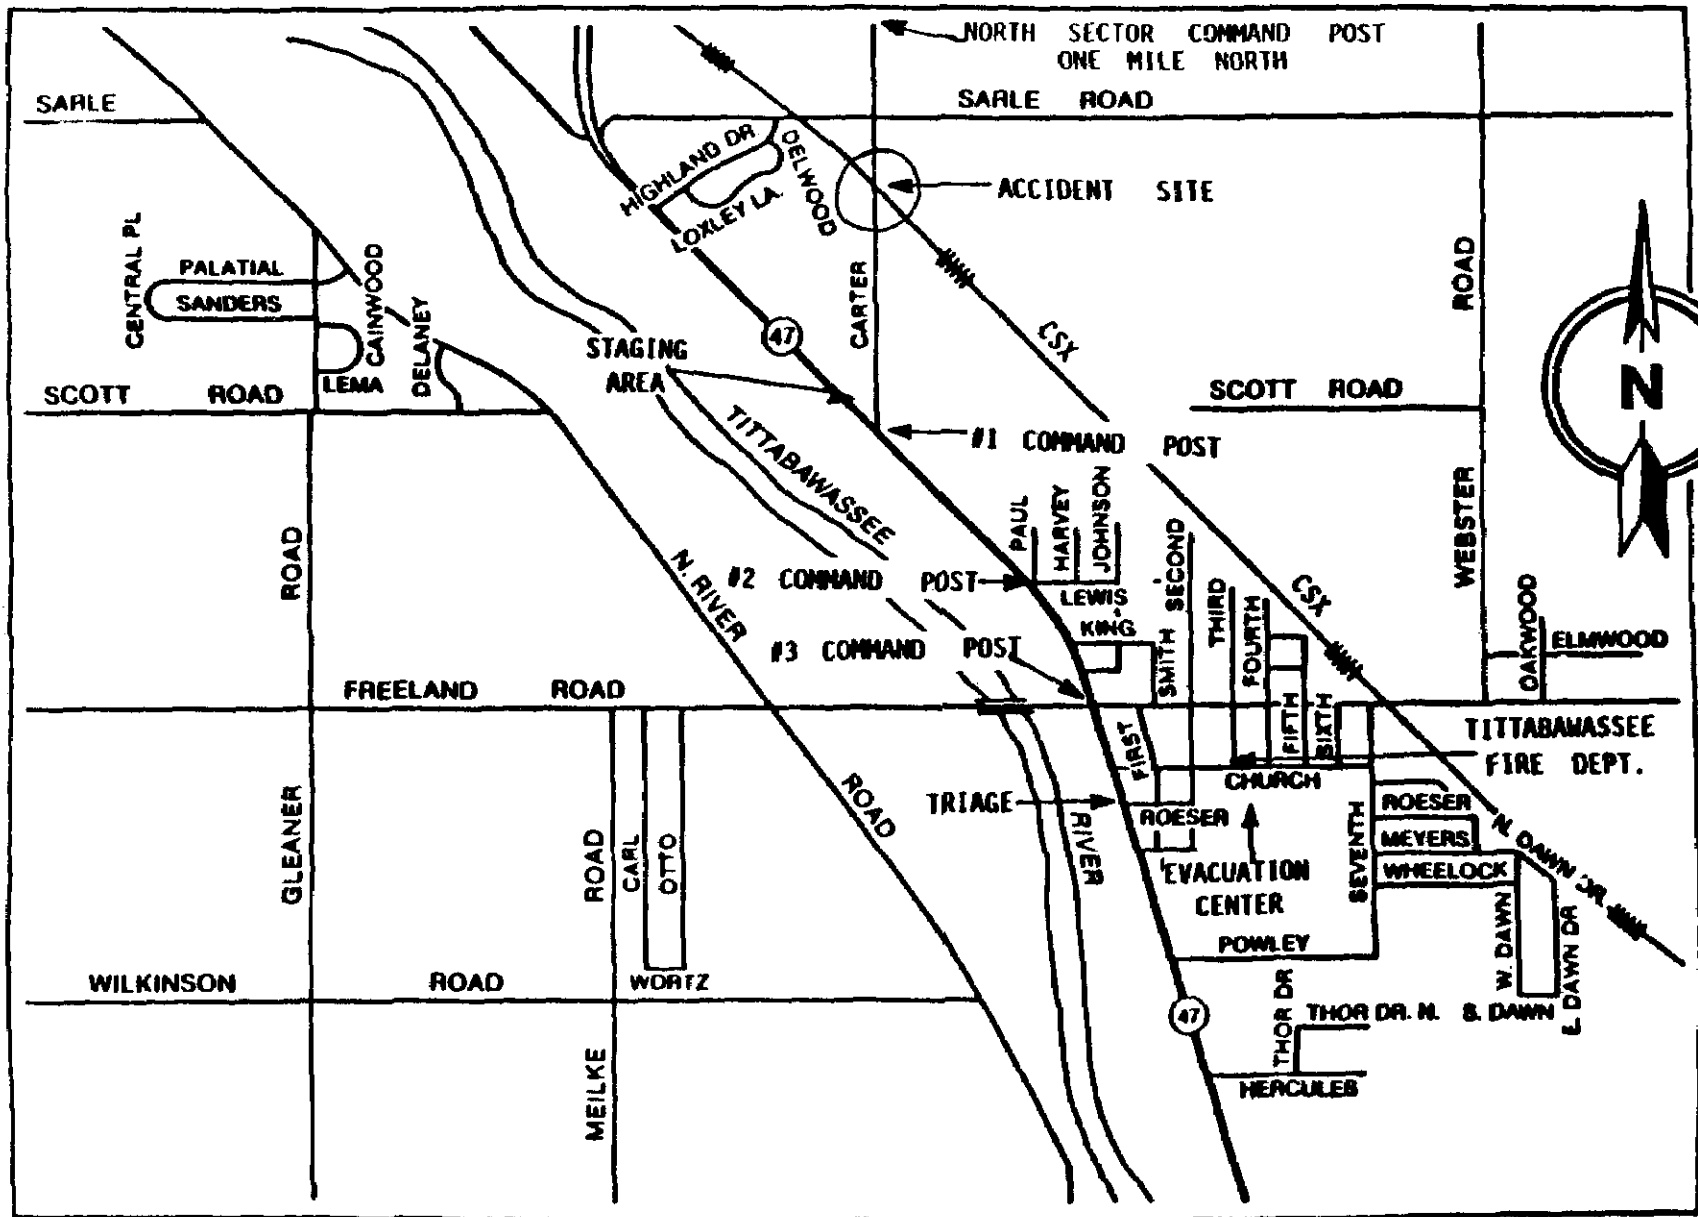
Figure 6.--Accident site and surrounding area, Freeland, Michigan.

The conductor sent an emergency radio message to the CSX dispatcher while the locomotive was coming to a stop during the accident sequence. The three crewmembers left the locomotives at once after they stopped. The conductor went from house to house north of the accident site, advising residents to leave immediately, the brakeman did the same south of the site. The engineer went to nearby highway 47 to alert motorists. (See figure 6)

Of the 14 freight cars that derailed, 6 were tank cars that sustained damage resulting in either partial or total loss of load. A flatcar loaded with a heat recovery steam generator (HRSG) module overturned, and the module was destroyed. One nearby residence was destroyed by the fire that ignited following the release of hazardous materials.

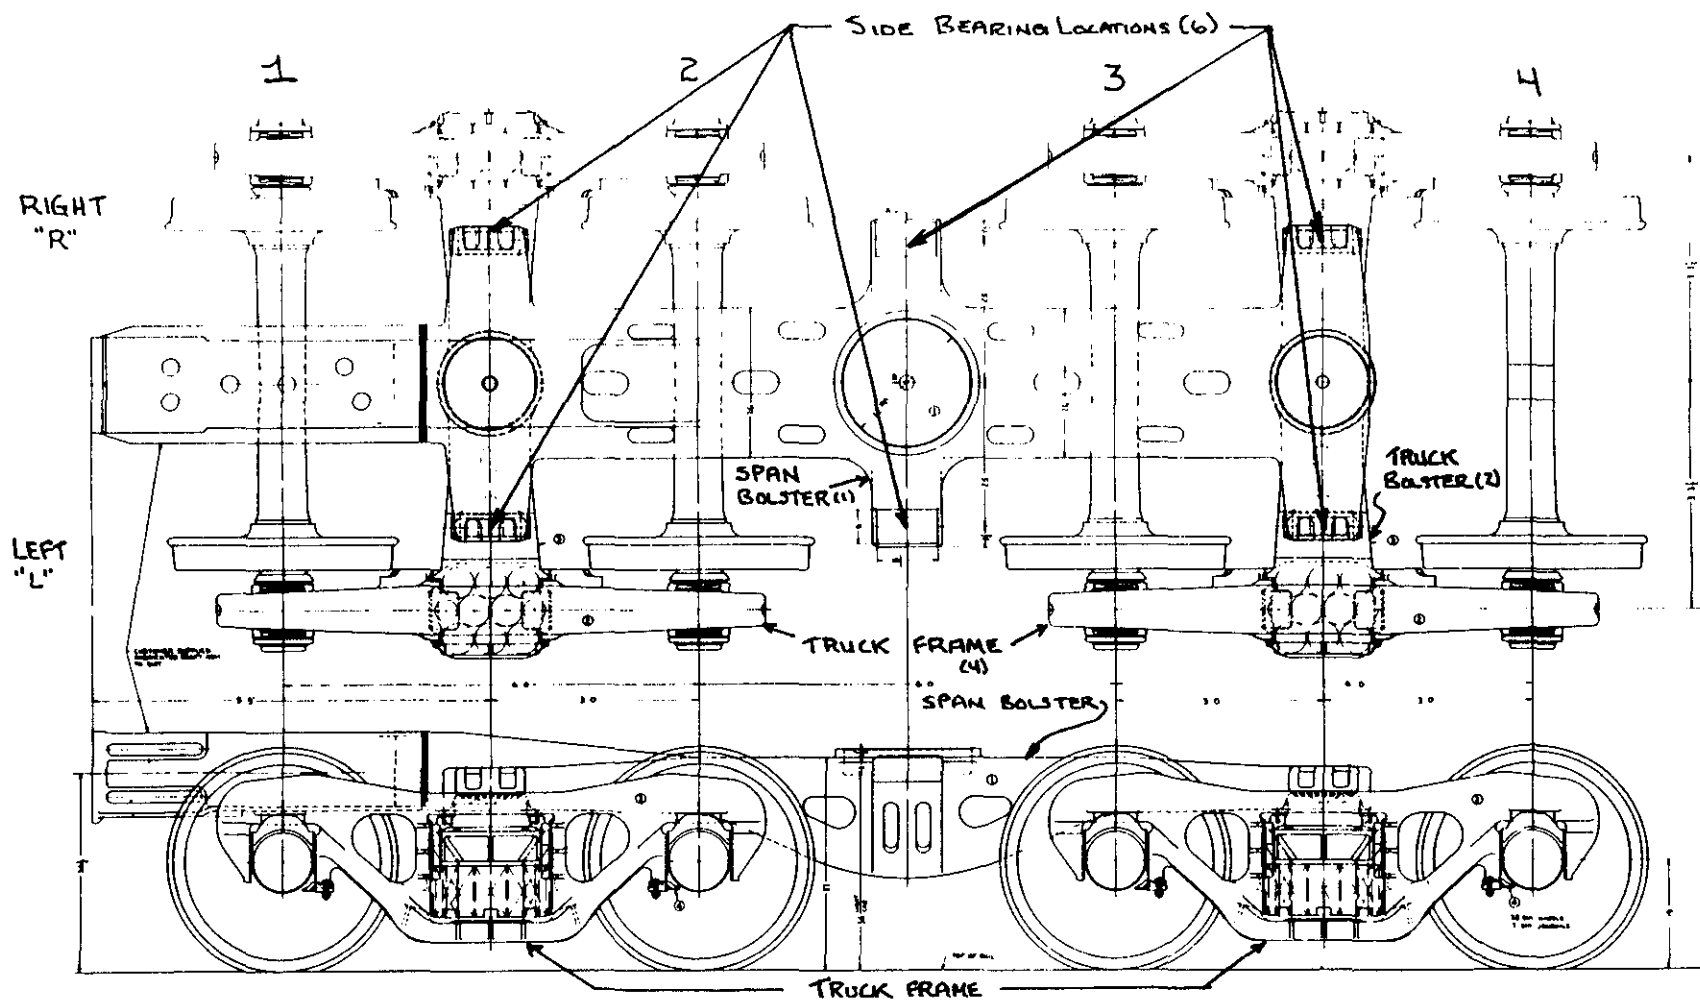
Figure 7 --Railcar truck assembly configuration

The car was configured with block-type side bearings and equipped at each end with two standard 100-ton, three-piece trucks. (See figure 7.) Load was transmitted from the primary center plates at each end and distributed through a span bolster to the truck center plates. This arrangement produced 12 side bearing clearance locations.⁸ The car was reassembled after the accident and side bearing clearance dimensions were reconstructed. All parties to the Safety Board's investigation at the time were invited to participate in the reconstruction, the Federal Railroad Administration (FRA), CSX, and ATSF elected to participate. Of the 12 locations, 11 had insufficient side bearing clearance. (See table 1.) Rule 47, section E, part 2 of the Association of American Railroads (AAR) field manual of interchange rules states that "side bearings must have 3/16 minimum to 5/16 inch maximum clearance."

⁸Six locations on each truck. Side bearings are load-bearing components, located either on the truck or body bolster, and are arranged to absorb vertical loads created by the car's rocking motion. Side bearing clearance refers to the space between mating body and truck side bearings on cars that have conventional side bearing arrangements.

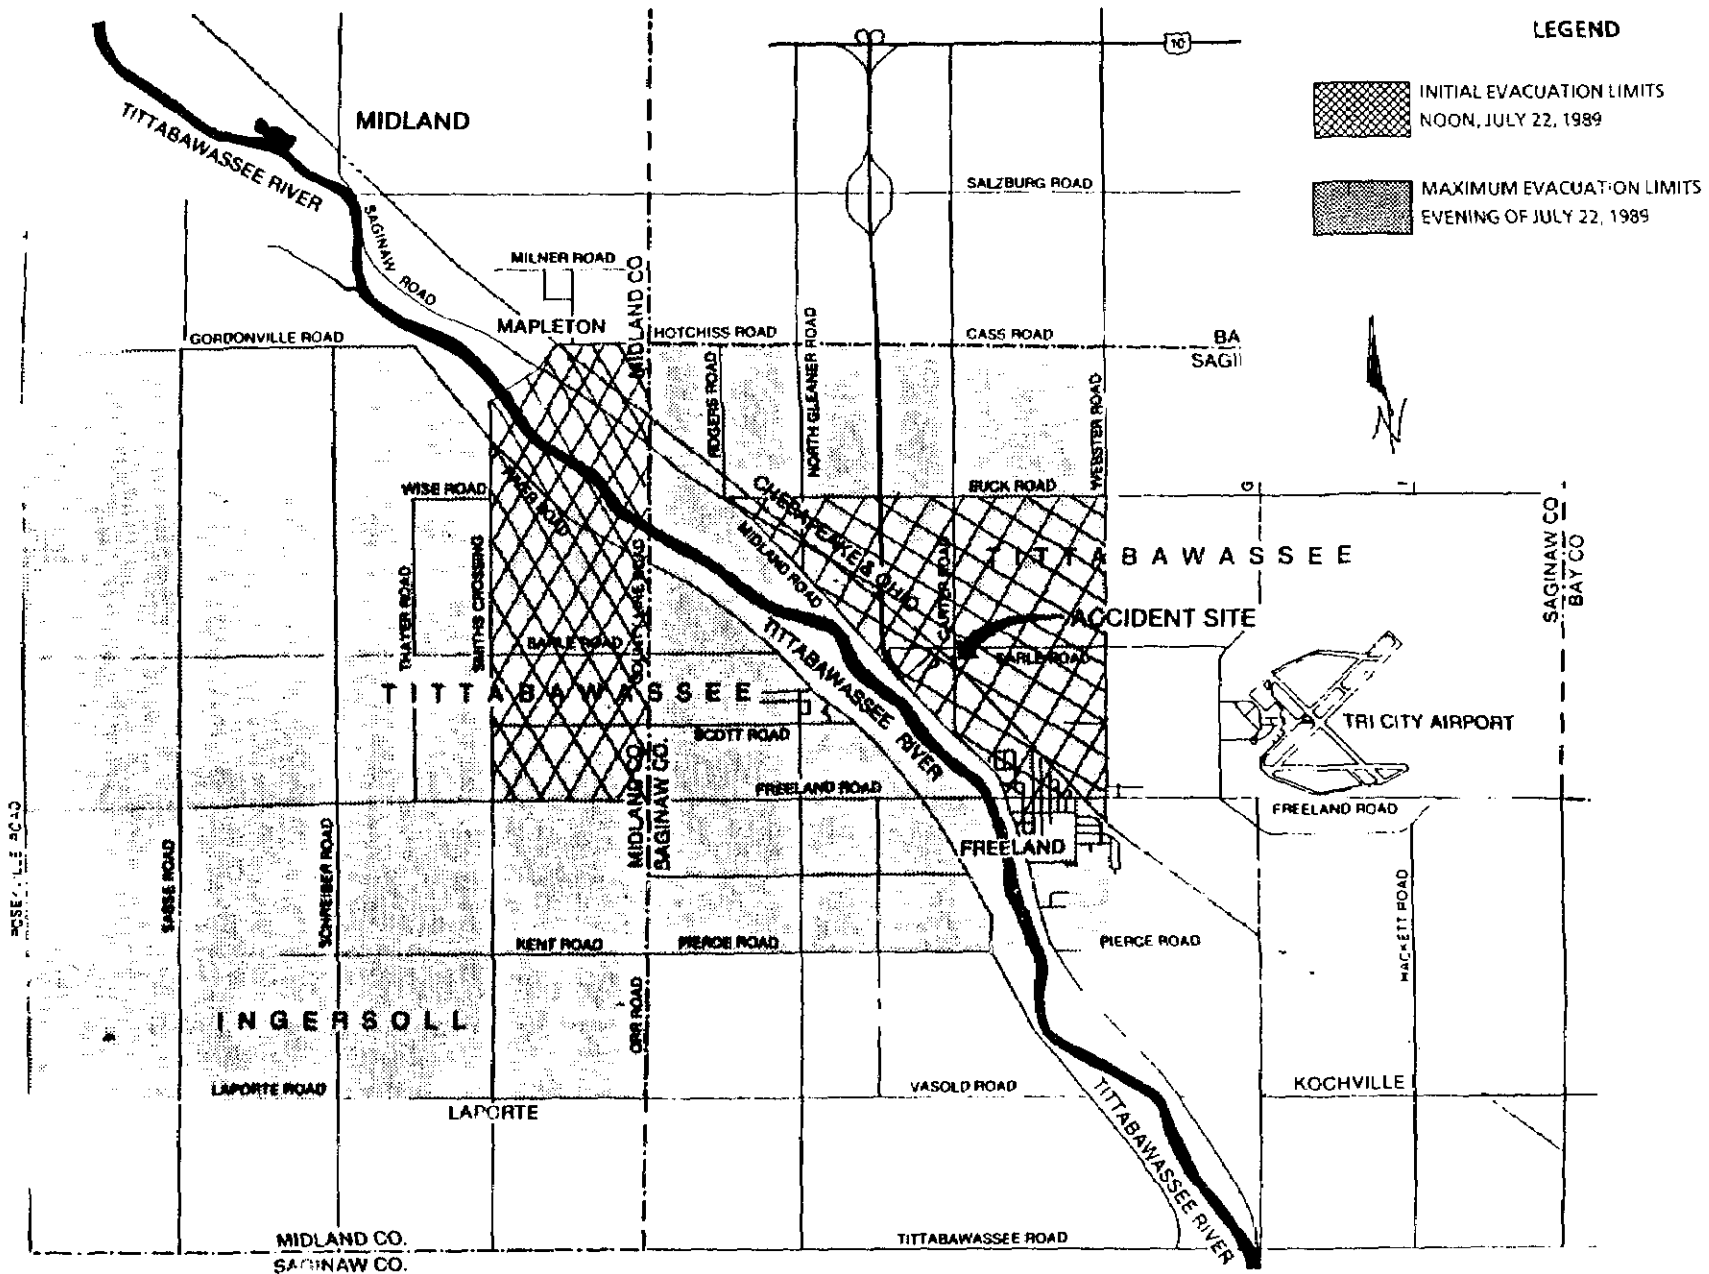
Figure 8 --Evacuation areas.

Evacuation --Although the traincrew had started the evacuation immediately, the TFD captain-in-command requested more personnel from Saginaw County Central Dispatch at 11 42 a m to help evacuate residents within a 1/2-mile radius of the accident site. Emergency response personnel had the train consist by then and knew which chemicals were being transported. However, they could not determine which chemicals were involved in the intense fire that had ignited after the railcars overturned. They based the initial evacuation area on the DOT Emergency Response Guide, which recommends a 1/2-mile evacuation for the chemicals that were reportedly involved. Estimates of the number of evacuees varied but were generally about 1,000. The Red Cross provided shelter. (See figure 8.)

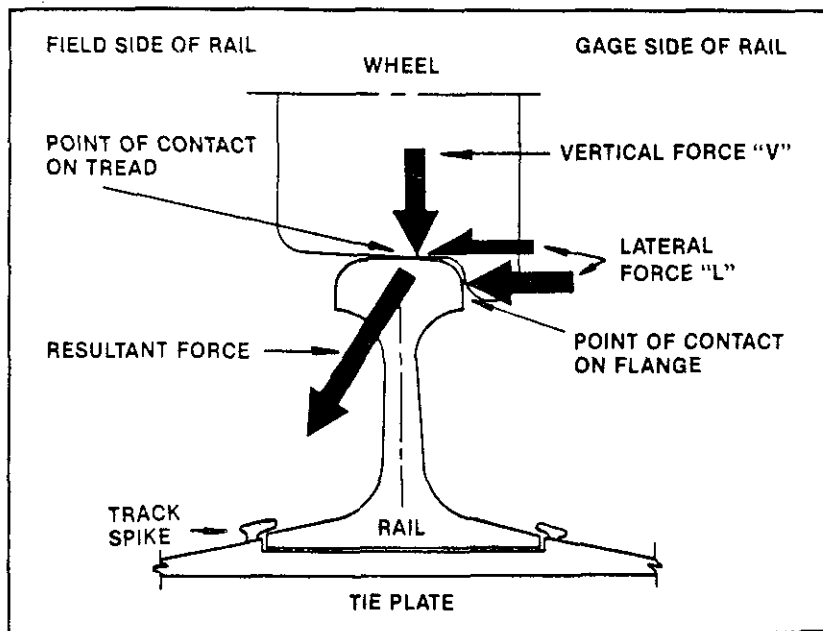
Figure 9 --Lateral to vertical force relationship between rail and wheel

According to the AAR Steering Committee for the Track Train Dynamics Program,³⁰ wheel lift derailments, which are related to the forces present at the wheel-rail interface, may be associated with track-train dynamics (see figure 9).

The reaction of forces at the wheel-rail interface will determine the tendency for a wheel to derail. The term commonly used to identify this reaction is L/V (L over V) [lateral to vertical force] ratio as shown in [figure 9]. The greater this ratio becomes, the greater the likelihood of derailment.
