REPORT NO. 3425  
THE PENNSYLVANIA RAILROAD COMPANY  
IN RE ACCIDENT  
NEAR NOTTAWA, MICH., ON  
AUGUST 28, 1951

Accident near Nottawa, Mich., on August 28, 1951, caused  
by a broken rail.

Report No. 3425  
 Pennsylvania Railroad  
 Nottawa, Mich.  
 August 28, 1951

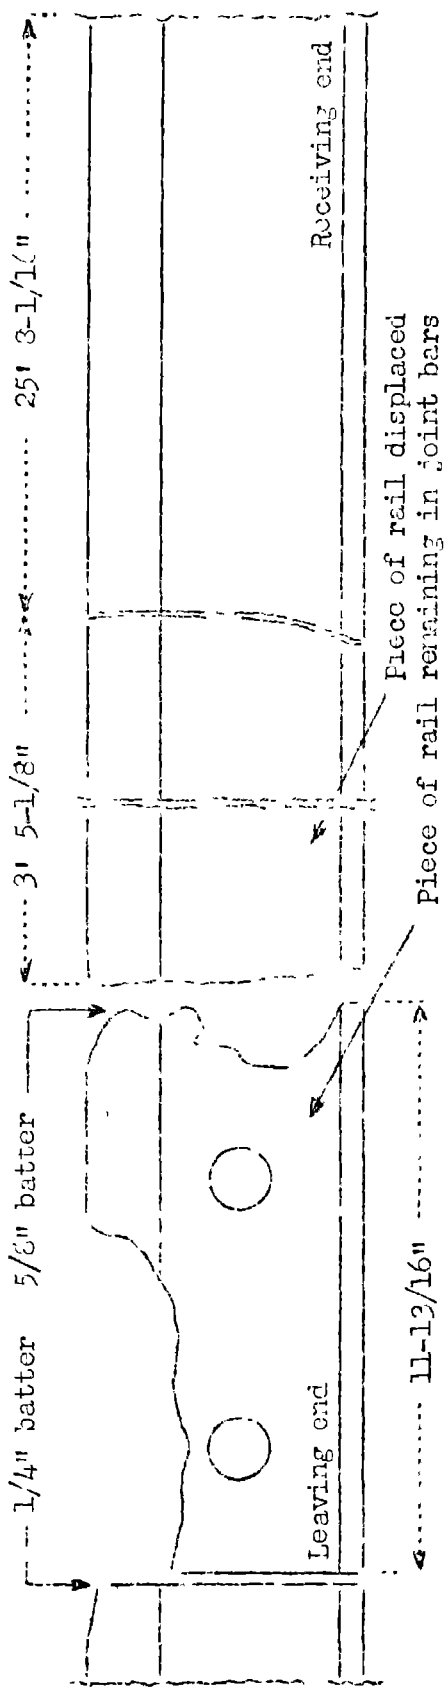
Sketch showing broken rail - west side of track

Examination of the track after the accident occurred disclosed no indication of dragging equipment nor of any obstruction having been on the track. The surface, alinement and gage were well maintained for the maximum authorized speed. At the point of derailment a broken rail was found on the west side of the track. This rail was broken into several pieces, three of which were recovered. From the north, in succession, the lengths of the three recovered pieces were 25 feet 8-1/8 inches, 3 feet 5-1/8 inches, and 11-13/16 inches. There was a portion between the second and the third pieces that was not recovered. The third piece of rail remained bolted in place. At the leaving end of this piece of rail, the head was broken out a distance of 7-1/4 inches. At the north end the head of the rail was battered downward a distance of about 5/8 inch. Small transverse fissures were found at

the break between the first and the second pieces, at the south end of the second piece, and at the north end of the third piece. None of the fissures extended to the surface of the rail. Flange marks on the pieces of rail which were recovered indicated that the section of rail immediately north of the third piece became displaced, and then the wheel flanges mounted the north end of the most southerly piece of rail.
