INTERSTATE COMMERCE COMMISSION  
WASHINGTON

REPORT OF THE DIRECTOR  
BUREAU OF SAFETY

ACCIDENT ON THE  
MICHIGAN CENTRAL RAILROAD

MONROE, MICH.

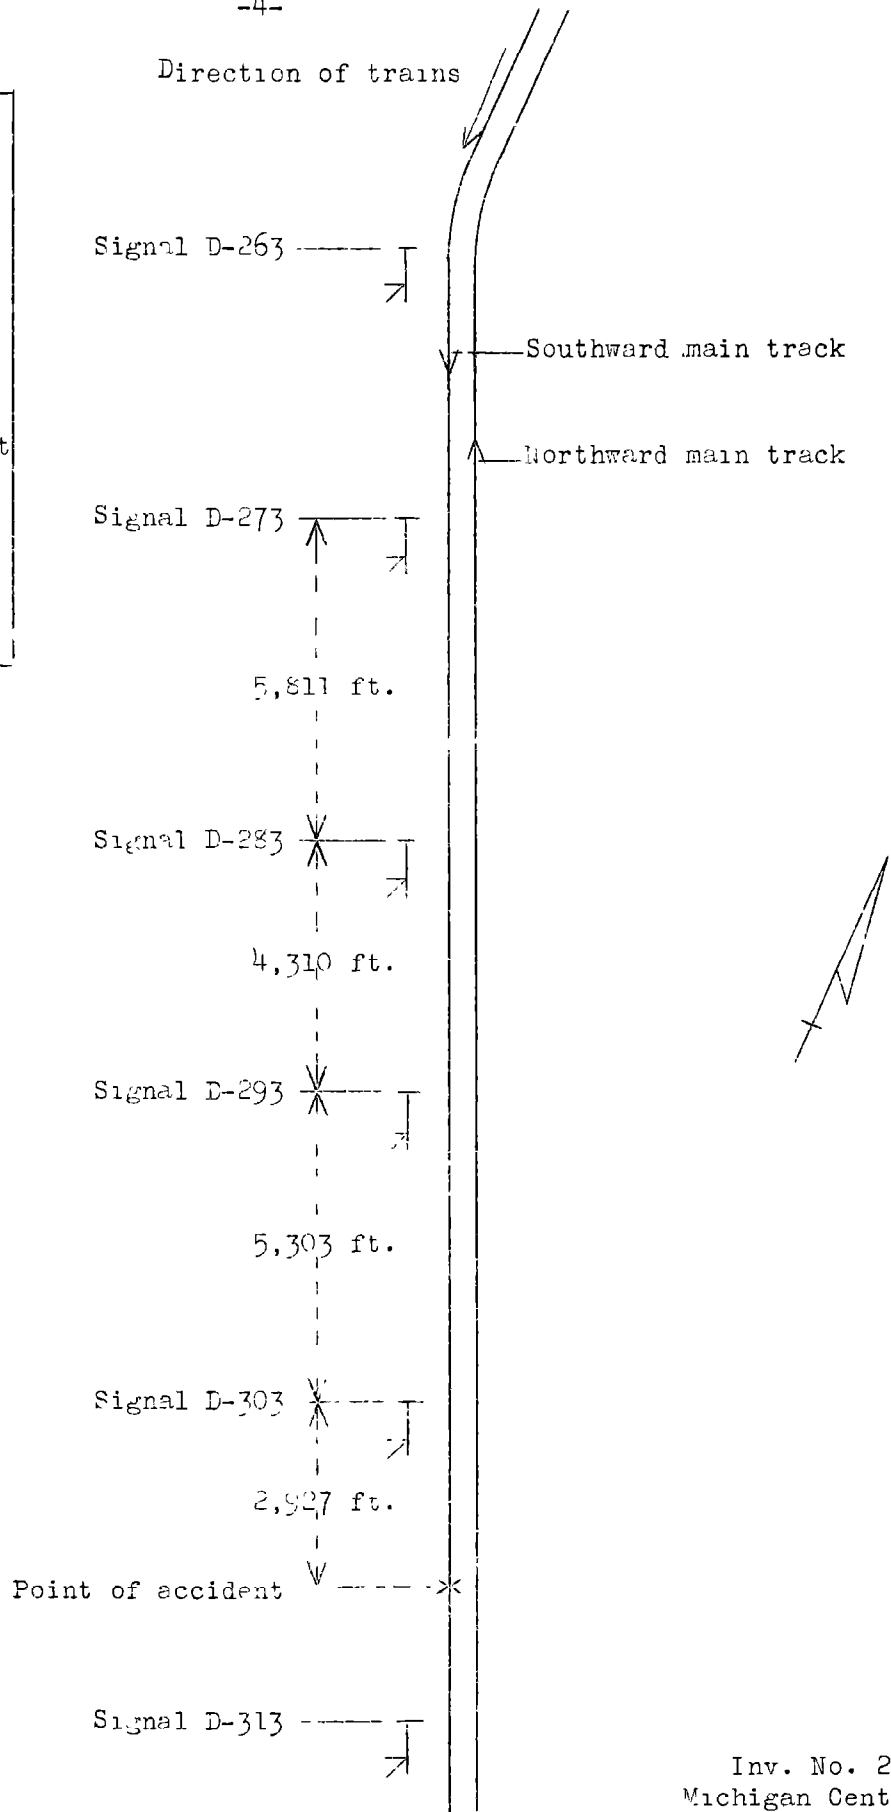
Inv. No. 2251  
 Michigan Central RR  
 Monroe, Mich.  
 Feb. 13, 1938

Direction of trains

o	Detroit, Mich.
	14.66 mi.
o	Trenton
	6.16 mi.
o	Rockwood
	5.62 mi.
o	Newport
	3.35 mi.
X	Point of accident
	4.03 mi.
o	Monroe
	23.75 mi.
o	Toledo, Ohio

This accident occurred on that part of the Detroit Division which extends between Detroit, Mich., and Toledo, Ohio, a distance of 57.57 miles. In the vicinity of the point of accident this is a double-track line over which trains are operated by timetable, train orders, and an automatic block-signal system supplemented by automatic train-stop devices of the intermittent-inductive type. The accident occurred on the southward main track at a point approximately 4 miles north of the station at Monroe. Approaching this point from the north the track is tangent for a distance of more than 5 miles to the point of accident, and for several miles beyond. The grade is practically level.
