INTERSTATE COMMERCE COMMISSION

REPORT OF THE DIRECTOR OF THE BUREAU OF SAFETY IN RE
INVESTIGATION OF AN ACCIDENT WHICH OCCURRED ON THE
GRAND TRUNK RAILWAY AT BATTLE CREEK, MICH., ON
FEBRUARY 7, 1931.

March 3, 1931.

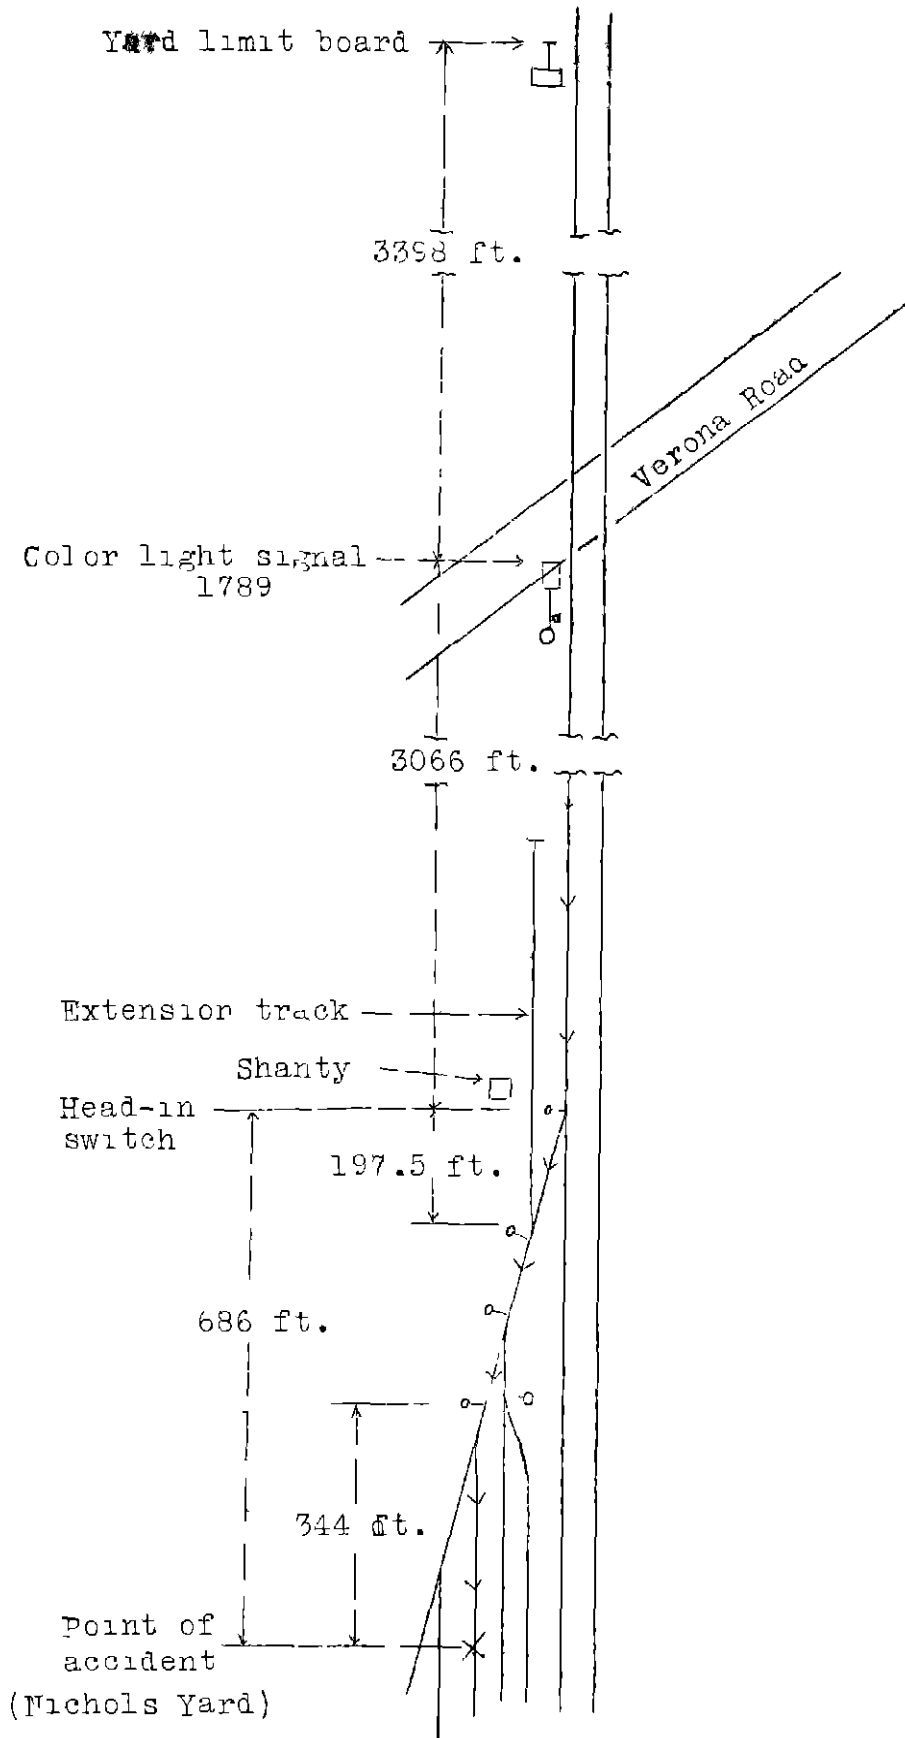
Inv. No. 1690
 Grand Trunk Ry.
 Battle Creek, Mich.
 February 7, 1931

The head-in switch is a facing-point switch for westbound trains and is located 7,465 feet west of the east yard-limit board, the switch stand being located between the westbound main track and an adjoining extension track, being of the low type and equipped with banner and lamp. The head-in switch leads off the westbound main track to the north through a crossover to the extension track, which track parallels the main tracks on the north. The crossover extends from southeast to northwest and is 197.5 feet in length, at a point about 37 feet west of the west switch of the crossover there is another switch that leads to yard track 2, while the switch leading to yard track 3 is located about 100 feet farther west, the accident occurring on yard track 3 at a point 344 feet from its lead track switch. There is a switch-tender's shanty located on the north side of the tracks opposite the westbound main line head-in switch. Westbound automatic color light signal 1789 is located 3,066.6

feet east of the head-in switch, at Verona Road, a public highway grade crossing; signal 1789 is 20 feet in height, and there is a head-in light signal located on the left side of the mast considerably below the automatic block signal lights. With both crossover switches reversed, that is, lined for a movement into Nichols yard, the automatic block signal 1789 displays a red indication and the yellow head-in light is displayed, when only one switch of the crossover is lined for a movement into the yard, the color light indication displays red, while the head-in light indication is not displayed.
